Investigation Report **6DG3 Debut Reflux Pump Failure**

Report Date: 1/20/11

On 12/1/10 at the CRU1 Spare Debutanizer Reflux Pump, 6DG3A, experienced a seal failure that led to an atmospheric butane release of 4300 lbs between 6:22 to 8:08 AM. This incident is classified as: API; D2 – Actual, C4 – Potential (People) and Process Safety Incident.

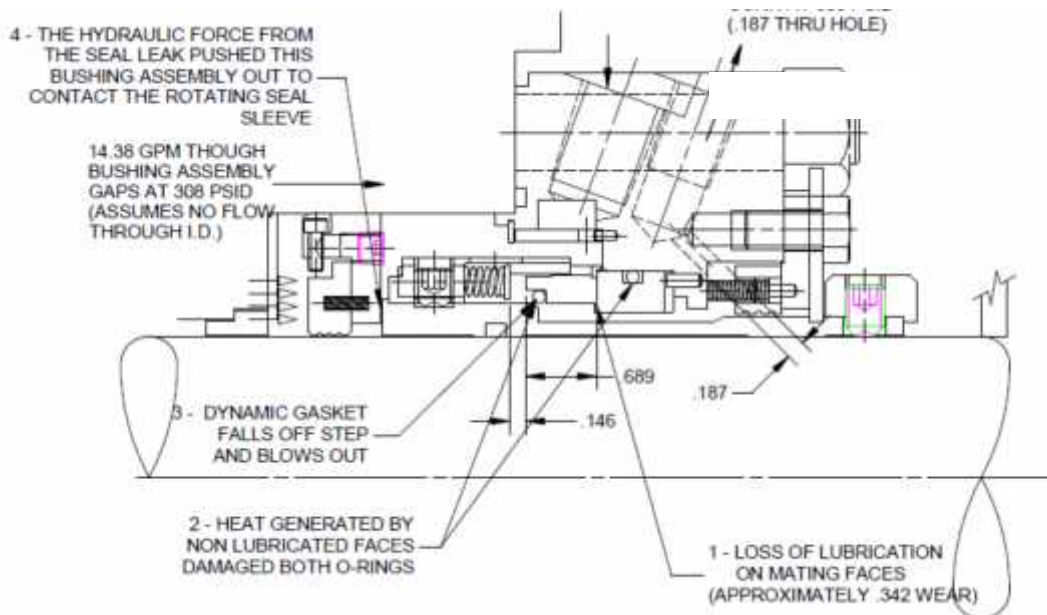
Figure 1 Seal Drawing with Sequence of Events Leading up to Failure

As noted in the history timeline, it is estimated that this pump (6DG3A) had approximately 2 weeks of run time leading up to the seal failure and during that time the seal faces ran completely or mostly dry. This caused the seal faces to wear such that the face magnitude of wear was greater than the travel for the rotating face gasket (aka, dynamic gasket or oring) causing the gasket to fall off the seal sleeve land (refer to figure 1). Once that happened, the mechanical seal faces were bypassed and a new atmospheric leak path was introduced. Note that the new differential pressure was great enough to move the close-clearance throat bushing into the back side of the rotating sleeve, causing galling.

The new seal design implemented an API plan 62 water quench to eliminate previous seal failures due to collection of solids on the seal faces. The new water quench required the mechanical seal gland drain plug to be removed to prevent the water from accumulating. The open seal gland drain plug now created a new leak path in the event of a seal failure. The open drain plug reduced the effectiveness of the installed pump seal disaster bushing.

4. Seal Water Quench Drain	
What cause should be addressed?	Since 7/30/10, 6DG3A seal had an open drain on the atmospheric side.
Why? What would be the benefit?	Pump seal design had water quench on atmospheric side of seal to reduce seal failures due to solids accumulation on atmospheric side of seal. Design requires open drain to prevent flooding of atmospheric section of pump seal gland. Open drain bypasses disaster bushing.
How? What would be the solution?	Reduce drain area that bypasses the disaster bushing by installing a restriction orifice.
How the solution would have prevented the incident	It would have reduced the amount of hydrocarbon that was escaping through the seal and water drain, but not have prevented the seal failure.

Action Plan:	Who: Matt Shores What: Update API plan 62 water quench standard drawing to include a note regarding potential issues to consider when opening the drain line. When: Complete
	Who: Jaylynn Jackson What: Conduct a survey for any disaster bushings with open drains from quench in all services. Develop recommendations for mitigation, if any. Open additional Fountain action items as necessary. When: 4/5/12
	Who: Jaylynn Jackson What: Validate if an API Plan 62 could be used in light hydrocarbon services. When: 4/5/12

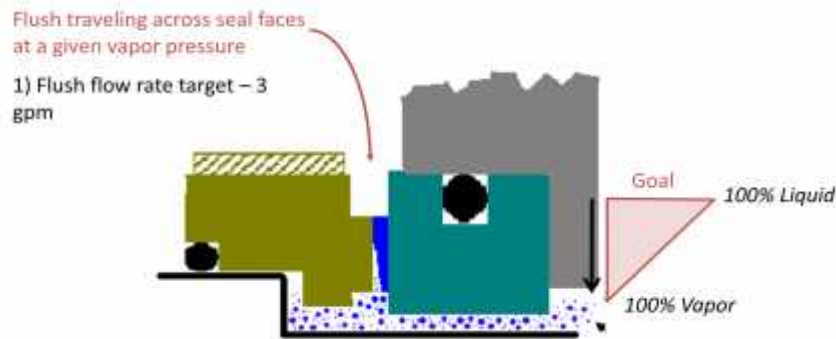
Figure 2 Seal Flush Operation/Design

Seal flush flow volume is critical to pump seal life as it removes heat, lubricates the seal faces, and increase the vapor margin (pressure) in the seal cavity thereby ensuring a lubricating environment for the mechanical seal faces. The goal is to have the liquid flush on the seal side gradually turn into vapor as it crosses the seal faces, such that there is less than 500 ppm vapor on the atmospheric side. A rule of thumb for selecting seal flush flow is 3.0 gpm and 25 psi vapor pressure margin or 30% above the vapor pressure, whichever is highest.

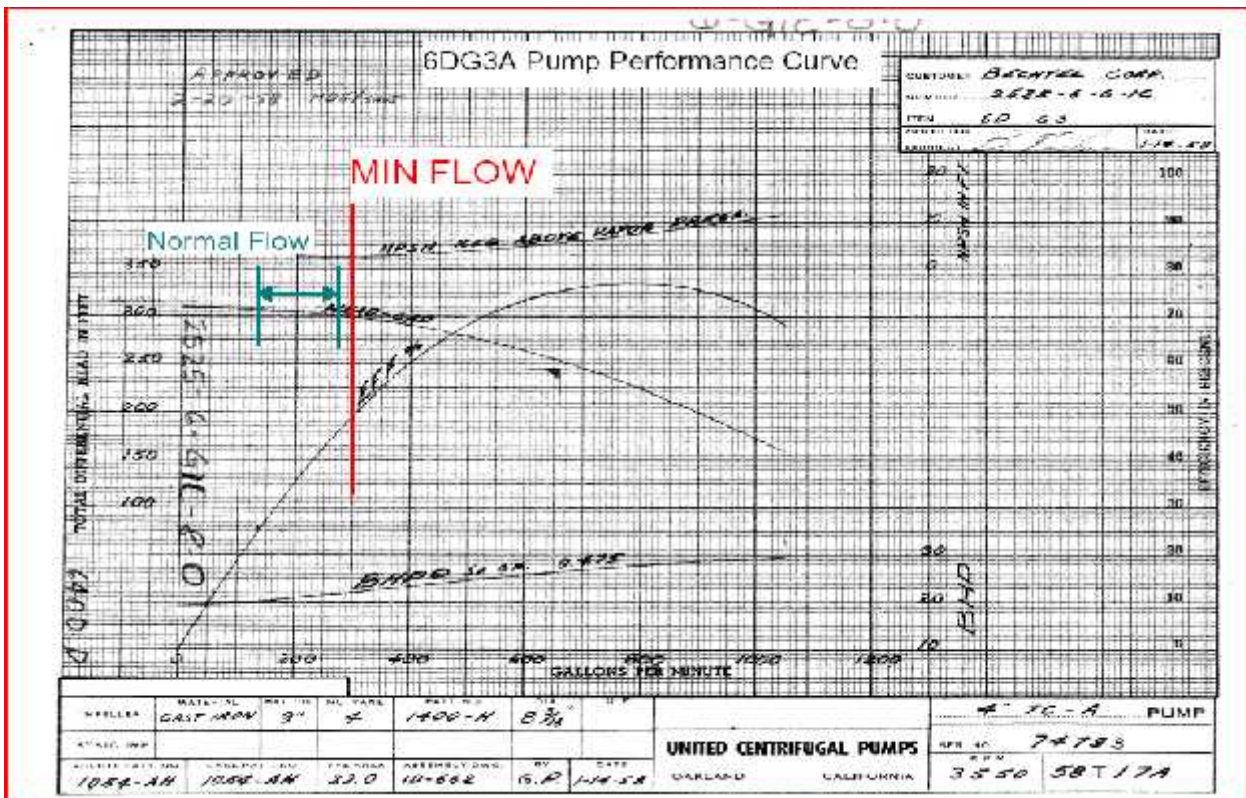
Figure 3 6DG3A Pump Performance Curve and Normal Operation

The two pumps while of different make and models both have a history of running 95% of the time below the minimum continuous flow of 400 BPH (@ 3600 rpm). The average flow rate in the

months leading up to this specific failure was 200-350 BPH. Due to difference in impeller designs the low flow rate (below minimum flow) more adversely impacted 6DG3A than 6DG3 causing high suction recirculation, increased vibration levels, and higher pumping temperature.

Low flow recirculation increases discharge temperature and therefore seal flush temperature. Higher temperatures of this fluid reduce the vapor pressure, thereby reducing the seal cavity vapor pressure margin even smaller.

1. Pump Operation Continuously Below Minimum Flow	
What cause should be addressed?	6DG3A was internally recirculating for the entire run period.
Why? What would be the benefit?	Recirculation caused by running below minimum flow for both debut reflux pumps was not only a contributing cause to this incident but has created a long history of low reliability.
How? What would be the solution?	Address the design of the 6DG3/3A pumps, which are way oversized for the service, by either slowing them down or replacing the impeller with something that would achieve both the operations needs for tower efficiency and minimum flow for the pump.
How the solution would have prevented the incident	Recirculation was a contributing factor to the reduced vapor pressure margin. It is unlikely that addressing this by itself would have prevented the issue (see recommendation #2).
Action Plan:	<p>Who: Matt Shores Action: Adjust operation of both 6DG3 and 6DG3A pumps to move normal operating values to above minimum flow by reducing the normal operating speed to 2850 rpm. Minimum flow of 315 BPH @ 2850 rpm. When: <u>Complete</u> per M2011225-001</p> <p>Who: Matt Shores Action: Implement pumps low flow target alarm of 315 BPH. When: <u>Complete</u> on same day as MOC M2011225-001</p> <p>Who: Matt Shores Action: Evaluate ability to re-rate 6DG3 to improve pump efficiency. When: <u>Complete</u>. Given pump case design and NPSHA constraints there is not an available pump re-rate.</p> <p>Who: Matt Shores Action: Evaluate ability to re-rate 6DG3A to improve pump efficiency. When: <u>Complete</u>. Pump can be re-rated with new impeller and pump case modifications. Re-rate would allow pump to run closer to BEP at 315 BPH than existing pump hydraulics.</p> <p>Who: Matt Shores Action: Evaluate need for minimum flow recirculation line. When: <u>Complete</u>. Min flow recirculation line will allow pump reliability to by running closer to BEP, but not required to run above minimum flow (315 BPH @ 2850 rpm).</p>
